## Appendix E

# Geologic and Seismic Hazards

The following definitions provide a more comprehensive discussion of the hazards that are described in the main body of the text of the Health and Safety Element.

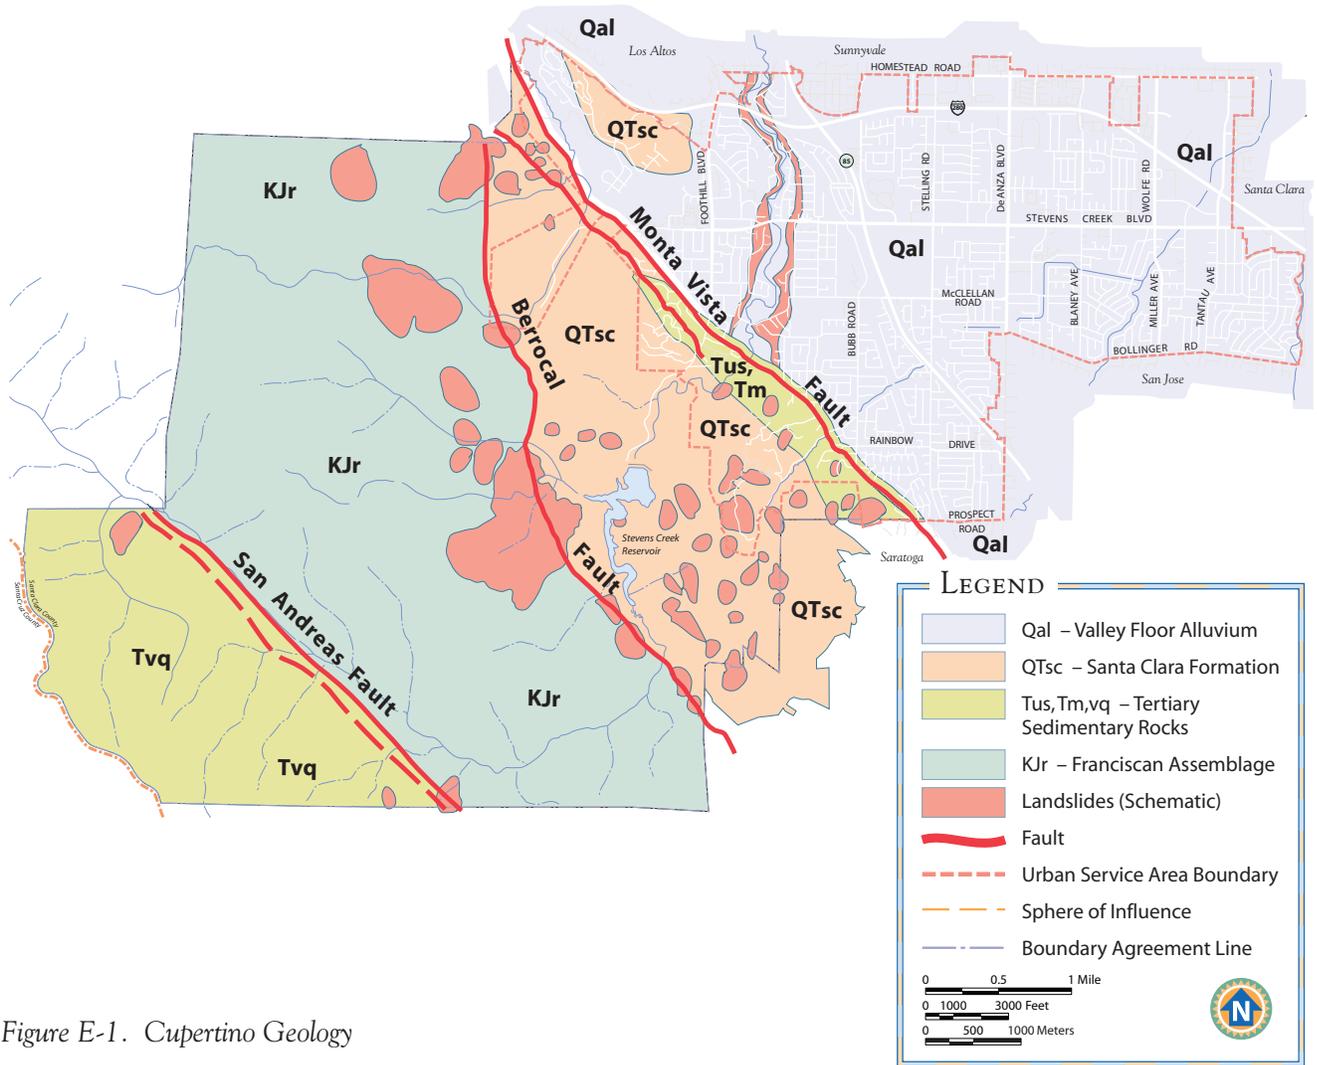
Figure E-1. Cupertino Geology

Figure E-1 on page 5 shows mapped landslide deposits within Cupertino. Geologic mapping in the hillsides shows that landslide deposits cover as much as 20 to 30 percent of the hillsides in the planning area. Landslides range from small, shallow deposits
